March 18, 2011

Apex Engineering, Inc.
27 West Market Street
Newport, Delaware 19804

**SUBJECT: WETLANDS INVESTIGATION OF 20 MONTCHANIN ROAD
NEW CASTLE COUNTY TAX PARCEL 07-030.10-015**

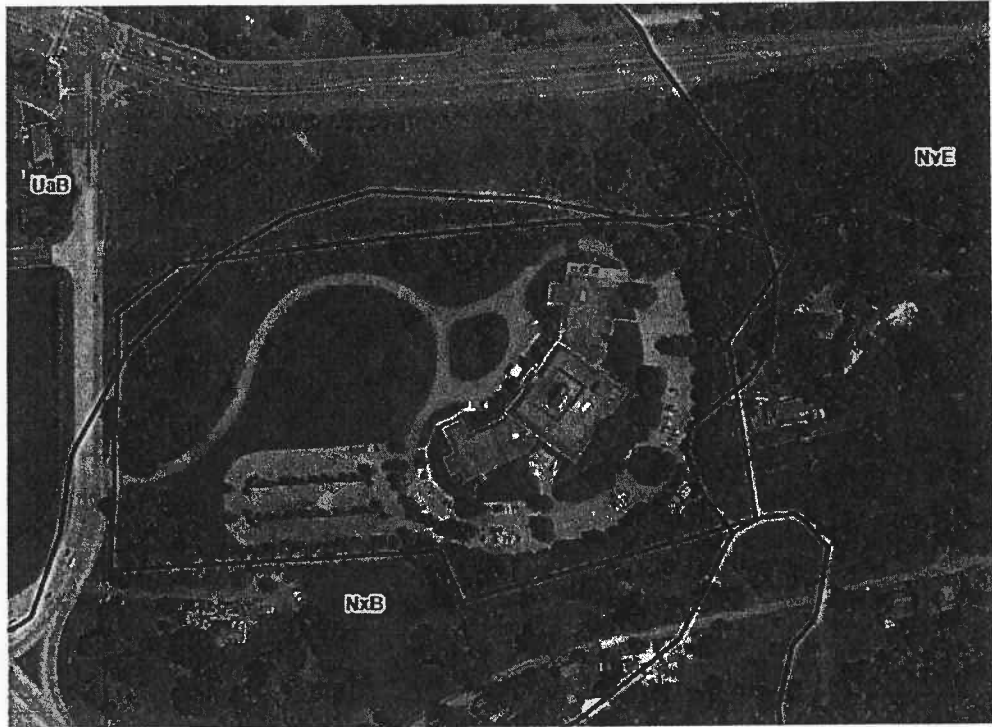
USDA Web Soil Survey

According to the USDA Web Soil Survey, the property is underlain primarily with Neshaminy Urban land complex (Nx B) with lesser areas of Neshaminy and Montalto silt loam (NvE), and Urthodents (UaB). The Neshaminy Urban land series consists of well-drained Neshaminy soils that have been disturbed through urbanization. The Neshaminy and Montalto series consists of well-drained soils that occur on the Piedmont Plateau. The Urthodents series consists of well-drained soils on ridges of the Piedmont Plateau. None of the mapped soil types are considered hydric by USDA Natural Resource Conservation Service.

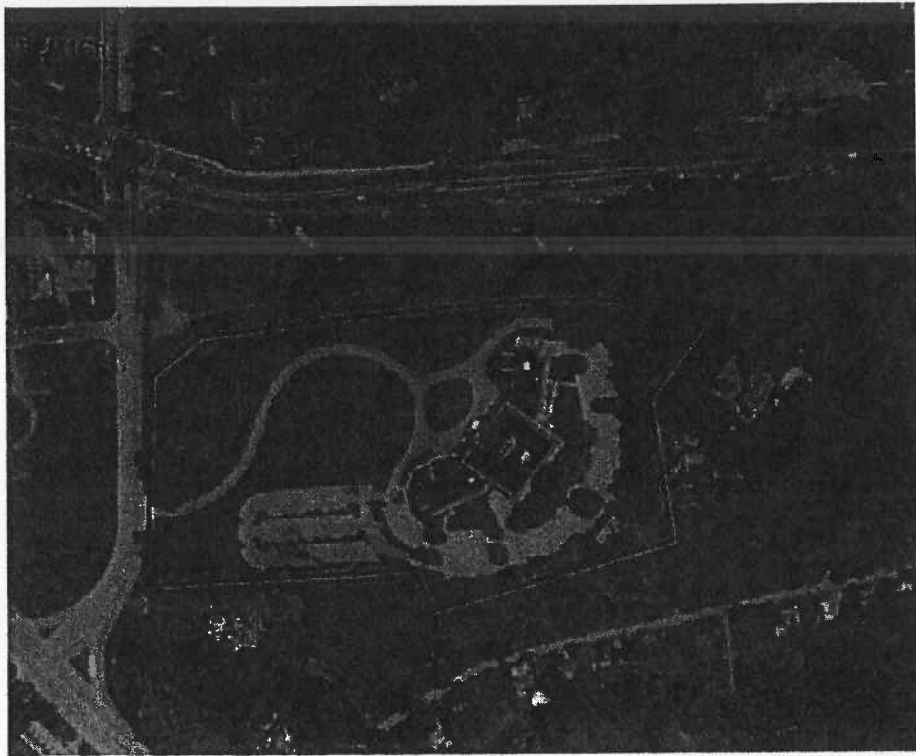
National Wetlands Inventory Map

Both the U.S. Fish and Wildlife Service National Wetland Inventory map and the Statewide Wetland Mapping Program map depict no wetland areas within or nearby the subject property (see attached maps).
